Manhole Inspection Summary

Manhole # S71E__003MH

Insp Date: **5/19/08 8:20 AM**

Location Address: **Quinton St**

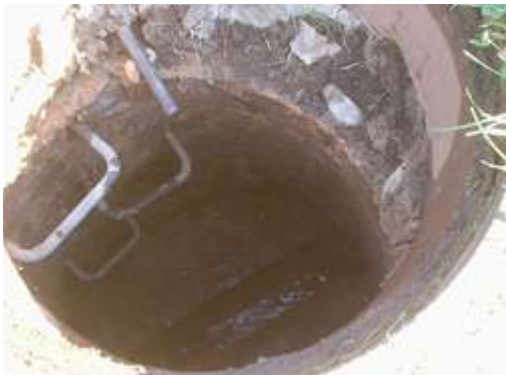
Defect 1

Frame Offset: **6** (in.) Condition: ☐ Sound ☐ Cracked ☒ **Leaks**

Infiltration: ☐ None ☒ **Joint** ☐ Cracks ☐ Mortar ☐ Roots ☐ Wall

Frame leaks

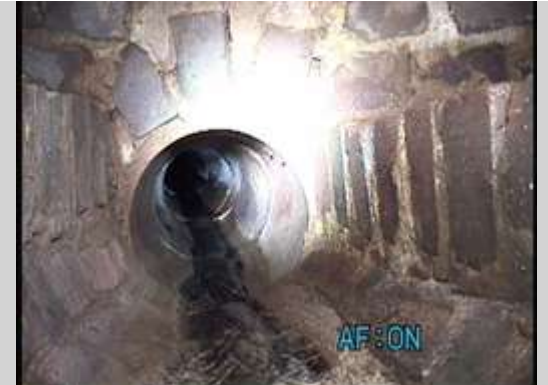
12 O'Clock Outflow

8 in. Circular Gravity Sewer
Pipe Out @ 12 O'Clock

Pipe Height: **8.4** (in.) Rod and Bar (Angled)
Pipe Material: **Clay** ☐ Pipe Lined
Invert Depth: **6.80** (ft.) Flow Characteristics: **Fast**
Deposits: ☒ None ☐ Mud ☐ Sludge ☐ Debris ☐ Grease
Silt Depth: (in.) Deposits Extent:
Infiltration: **None** Pipe Seal Cond: **Sound**

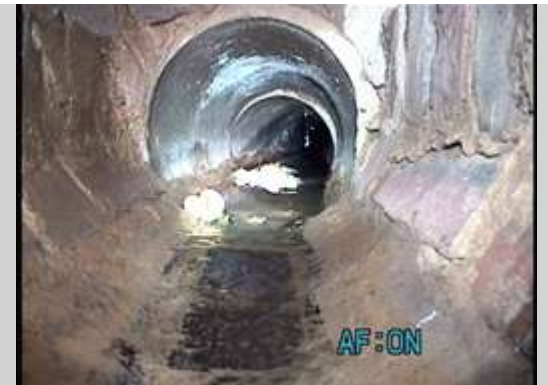
6 O'Clock Inflow

8 in. Circular Gravity Sewer
Pipe In @ 6 O'Clock

Pipe Height: **8.4** (in.) Rod and Bar (Angled)
Pipe Material: **Clay** ☐ Pipe Lined
Invert Depth: **6.60** (ft.) Flow Characteristics: **Fast**
Deposits: ☒ None ☐ Mud ☐ Sludge ☐ Debris ☐ Grease
Silt Depth: (in.) Deposits Extent:
Infiltration: **None** Pipe Seal Cond: **Sound**
